**Exploratory investigation**  
**Fire with fatal outcome in De Punt**

I. Helsloot  
E. Oomes  
R. Weewer

18 June 2008

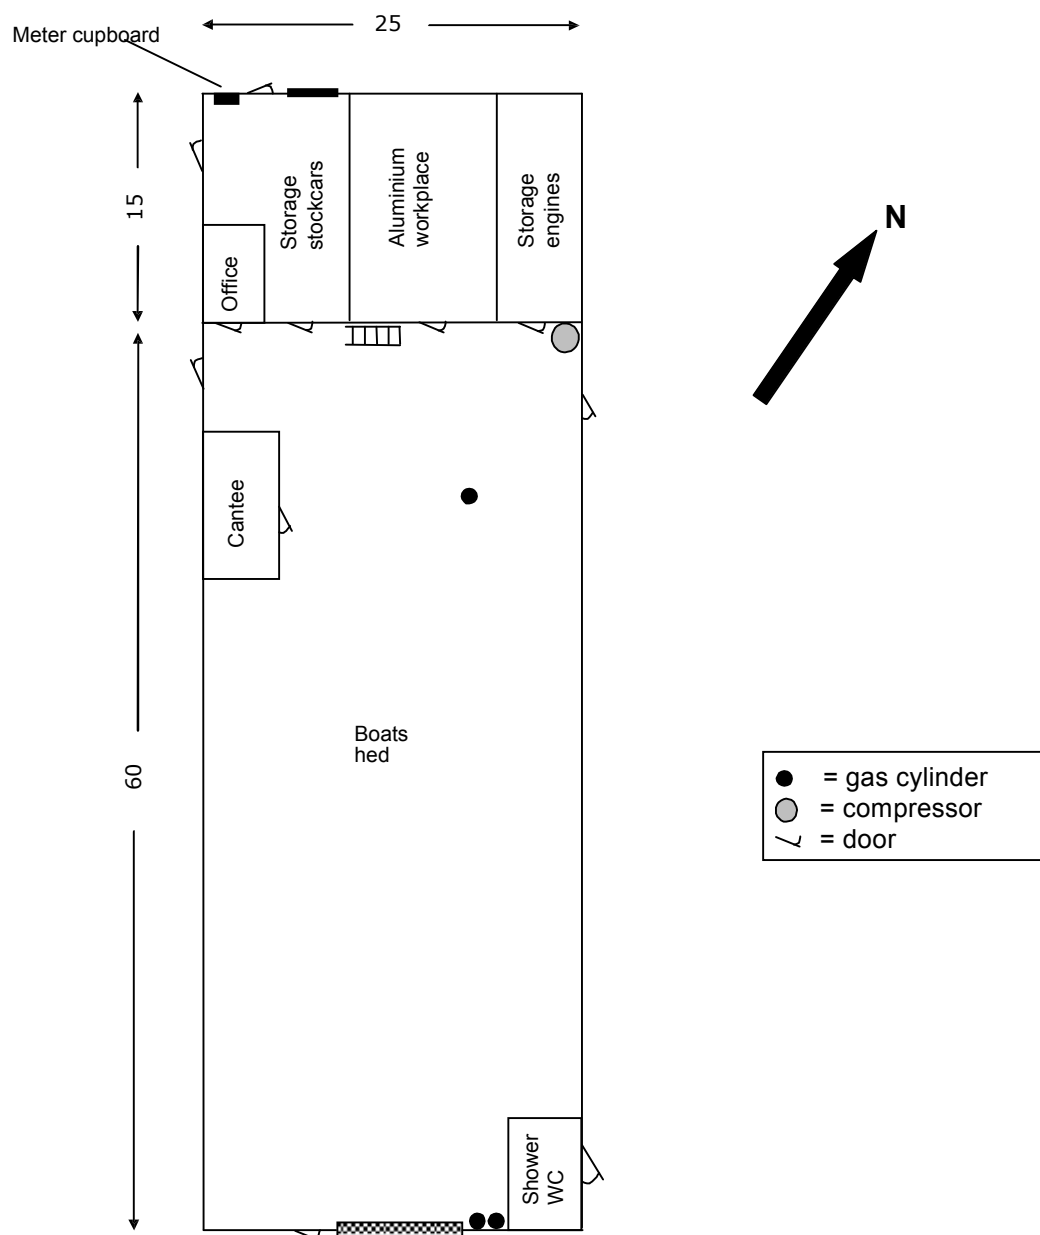
**Figure 1:** Ground plan of the boatshed located in the Groningerstraat 118 in De Punt.

The building in question is located at the Groningerstraatweg 118 in De Punt, the Netherlands, and is used as a boatshed and/or repair shop for pleasure boats. The boatshed is 25 metres wide and 75 metres long (see figure 1).

The boatshed was divided into several walled-in spaces. The relevant spaces are included in figure 1. At the back of the building, there were three separate spaces of each 15 metres deep, to be used for several activities: The space (seen from the front) to the left is 10 metres wide, consisted of an small office, followed by a storage and equipped with its own sliding door. This space was also used for repair work on (stock) cars. Furthermore, on the back wall of this room a meter cupboard and a gas meter were located. The aluminium workplace, also 10 metres wide, was located in the middle of the boatshed and was used for manufacturing porthole frames out of aluminium strips. The smaller space on the right was 5 metres wide and used for the storage of engines. Each of the spaces, including the small office, had its own entrance giving access to the rest of the building (the boatshed).

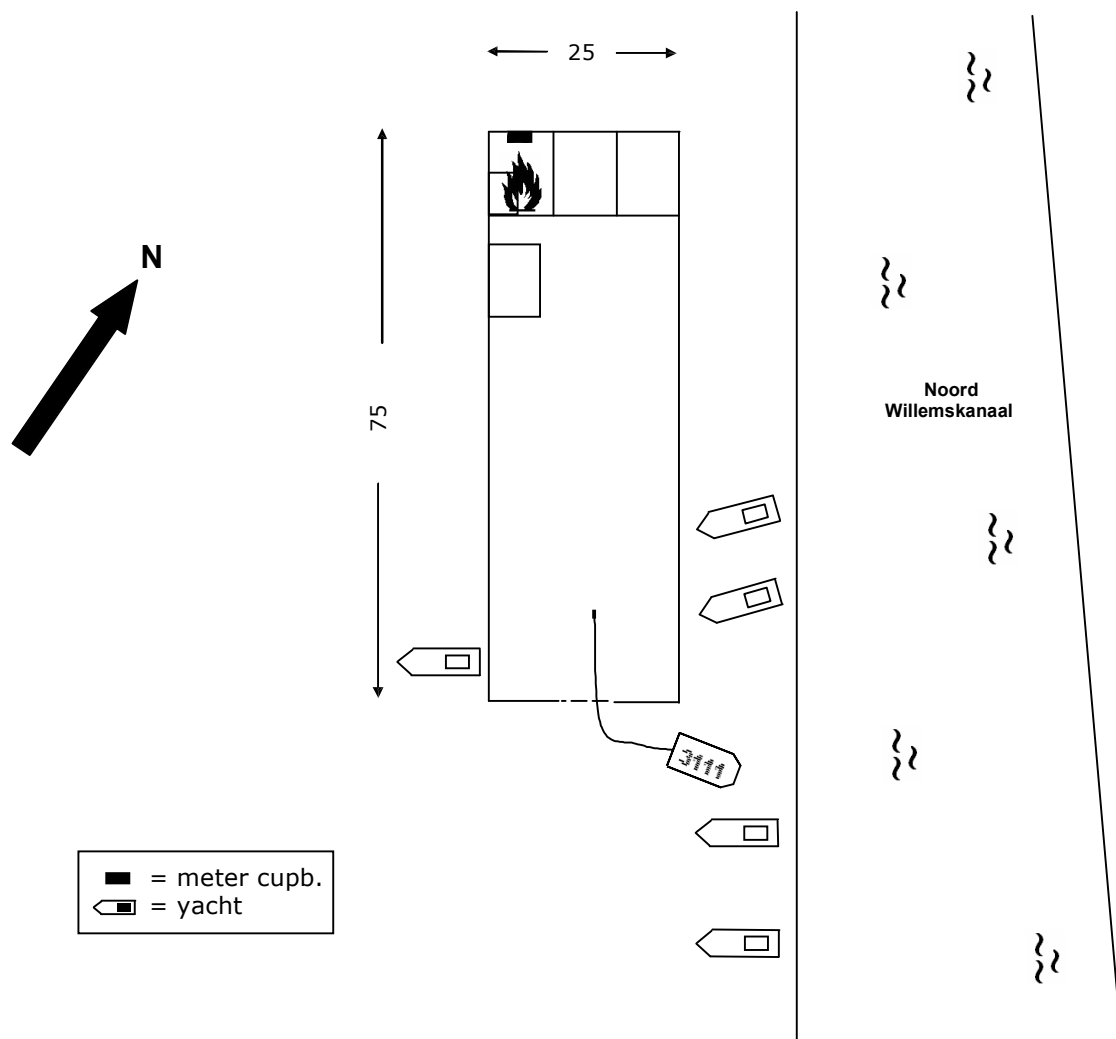
**Figure 2:** Situation shortly before sudden spread of fire (approx. 14.20 hours).

Outside the field of vision of the firemen, at the front of the boatshed, during the approx. 2 or 3 minutes that have passed since the TS 3111 drove over the roundabout, the pattern of the fire at the rear has deteriorated dramatically: a black plume of smoke is being forced out of the ridge of the roof, and yellow-brownish smoke is billowing out from the edges of the roof. This incites a colleague from the fire service Vries, who passes by the boatshed, to call the control room and request scaling-up of the fire to a middle fire, the very moment he receives the message 'middle fire' on his pager.

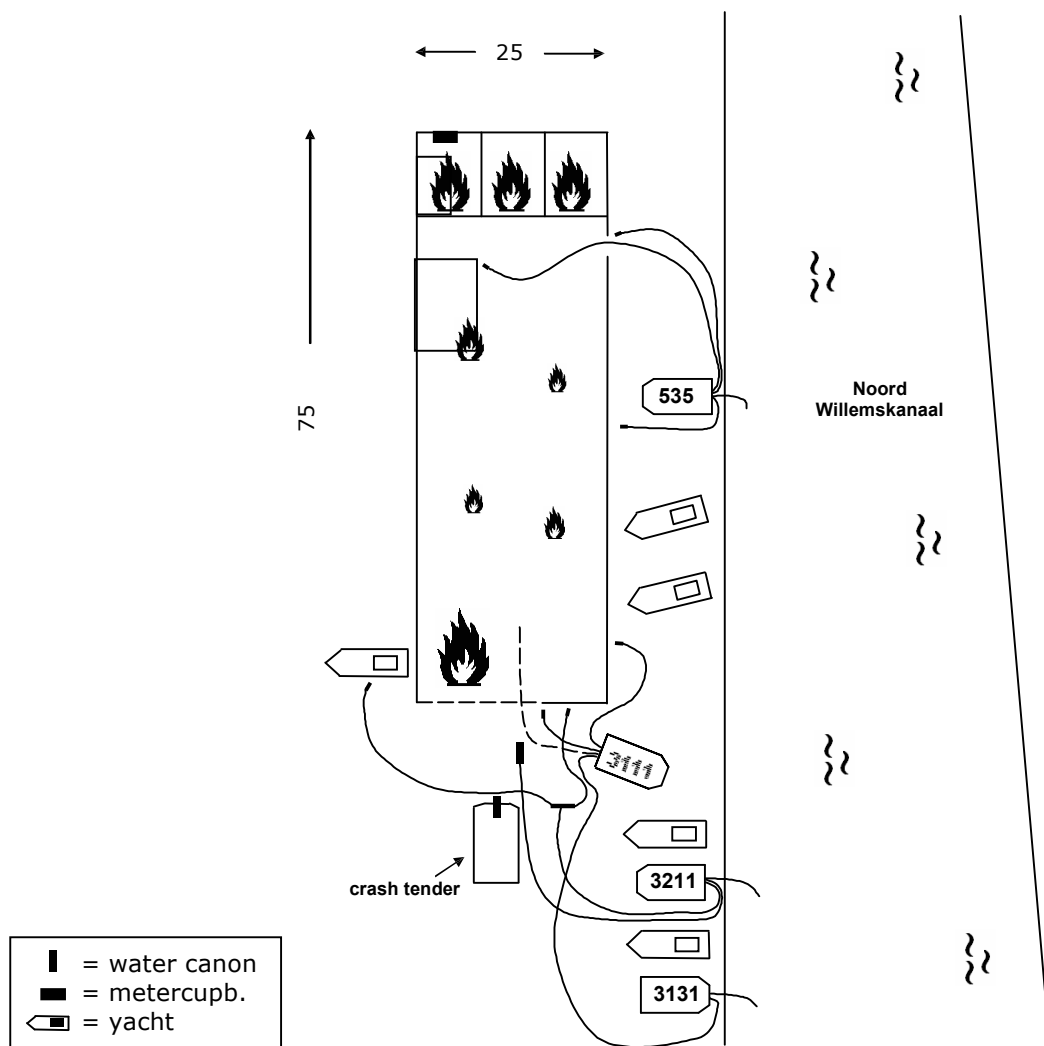
**Figure 3:** Situation layout at approx. 2.40 PM.

The fire engine from Haren (535) is given the orders by the Duty officer to operate at the back of the building<sup>26</sup> The 535 takes however a different entrance and positions itself on the waterside of the boatshed, covered by a water canon (see below).
